# Manhole Inspection Summary

Manhole # S02GG2001MH

**Location** Address: **3201 FALLSTAFF RD**

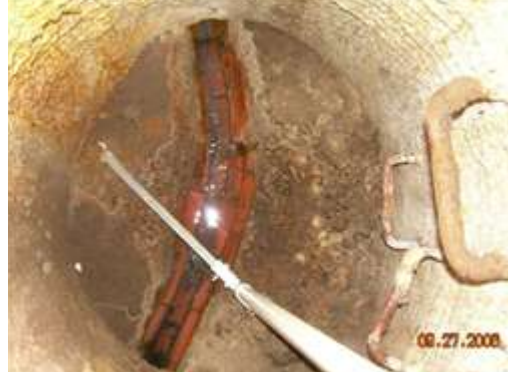
Top View

Corroded steps. Evidence of surcharge - Bench debris.

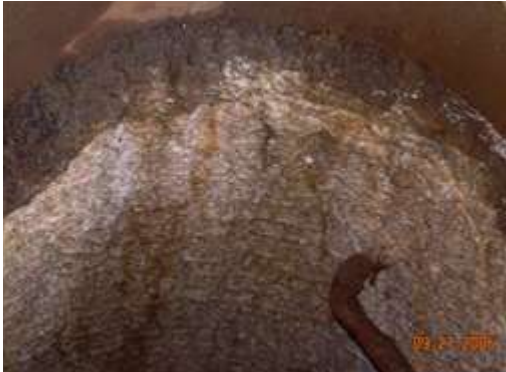
Defect

Frame leaks. Frame offset. Adjustment infiltration.

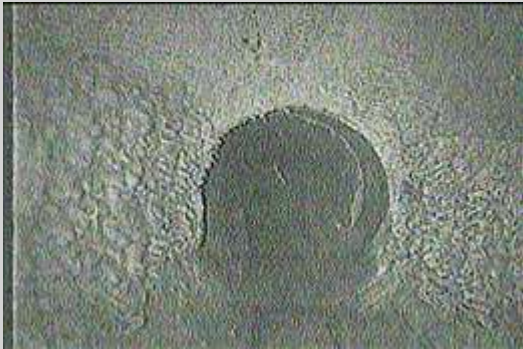
### 8 in. Circular Gravity Sewer Pipe Out @ 12 O'Clock

Invert Depth: **6.60** (ft.) Flow Characteristics: **Slow**

Infiltration: **None** Pipe Seal Cond: **Unknown**

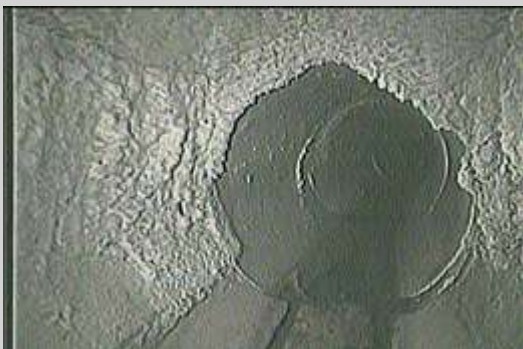
### 8 in. Circular Gravity Sewer Pipe In @ 7 O'Clock

Invert Depth: **6.50** (ft.) Flow Characteristics: **Slow**

Infiltration: **None** Pipe Seal Cond: **Unknown**
